**DECLARATION OF DARKO BABIC**

*Failure Analysis Associates*

**Piskura v. TASER  
International Inc.**

October 31, 2011

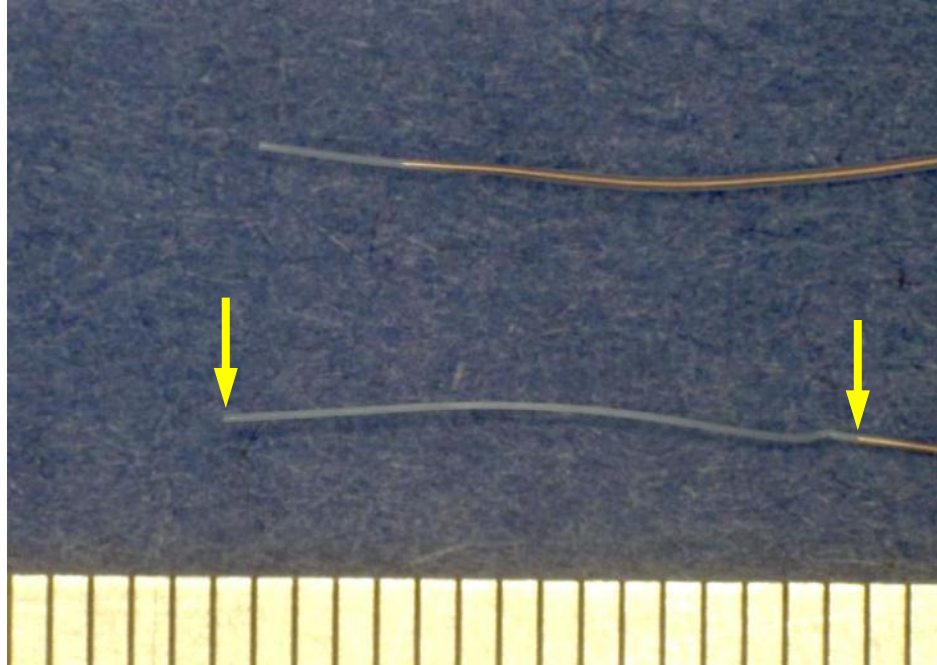
After each test, the broken wire ends were examined to observe their condition. In every test conducted, the insulation material had stretched and extended beyond the fractured metal ends at the fracture location (Figure 7, Figure 8). This prevented subsequent direct contacts with the metal wire from occurring. Thus, if the newly fractured ECD wire were to become a part of an electrical circuit capable of delivering an electric charge, the electricity would have to bridge the air gap created by the stretched insulation material. In other words, arcing would have to occur, and visible evidence of this would be created, such as melted insulation or charred material.

Figure 7. Condition of the broken wire ends for sample 1-25-2-L – slowest loading rate. Note the significant stretch of the insulation material (between the yellow arrows – millimeter scale at the bottom).

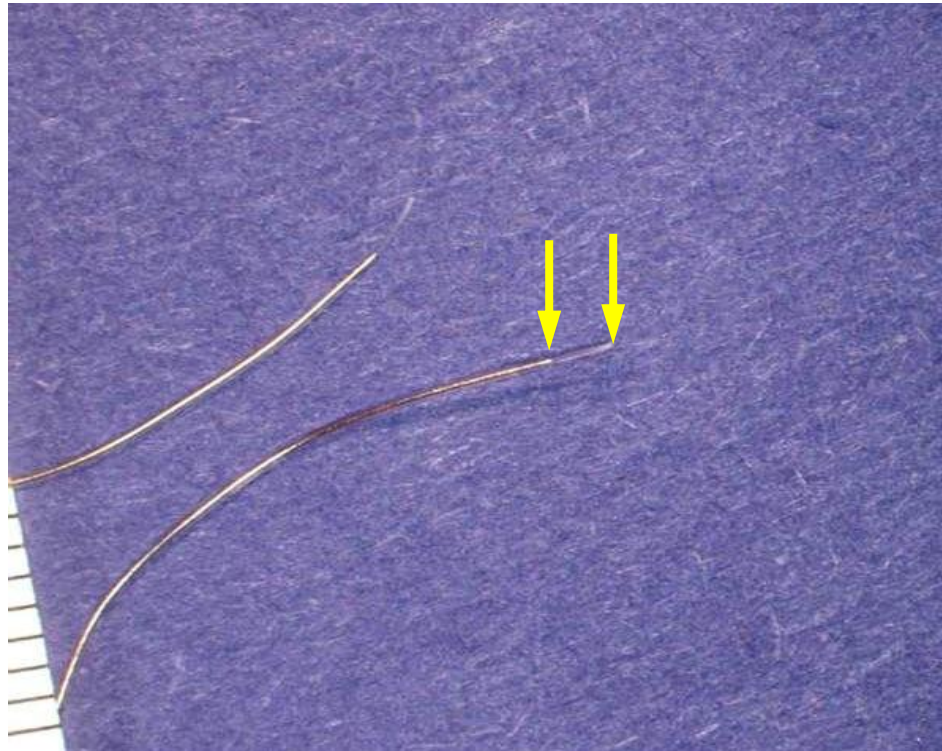
Figure 8. Condition of the wire tips for sample 1-25-1-L – highest loading rate. Note the less pronounced stretch of the insulation material (between the yellow arrows).

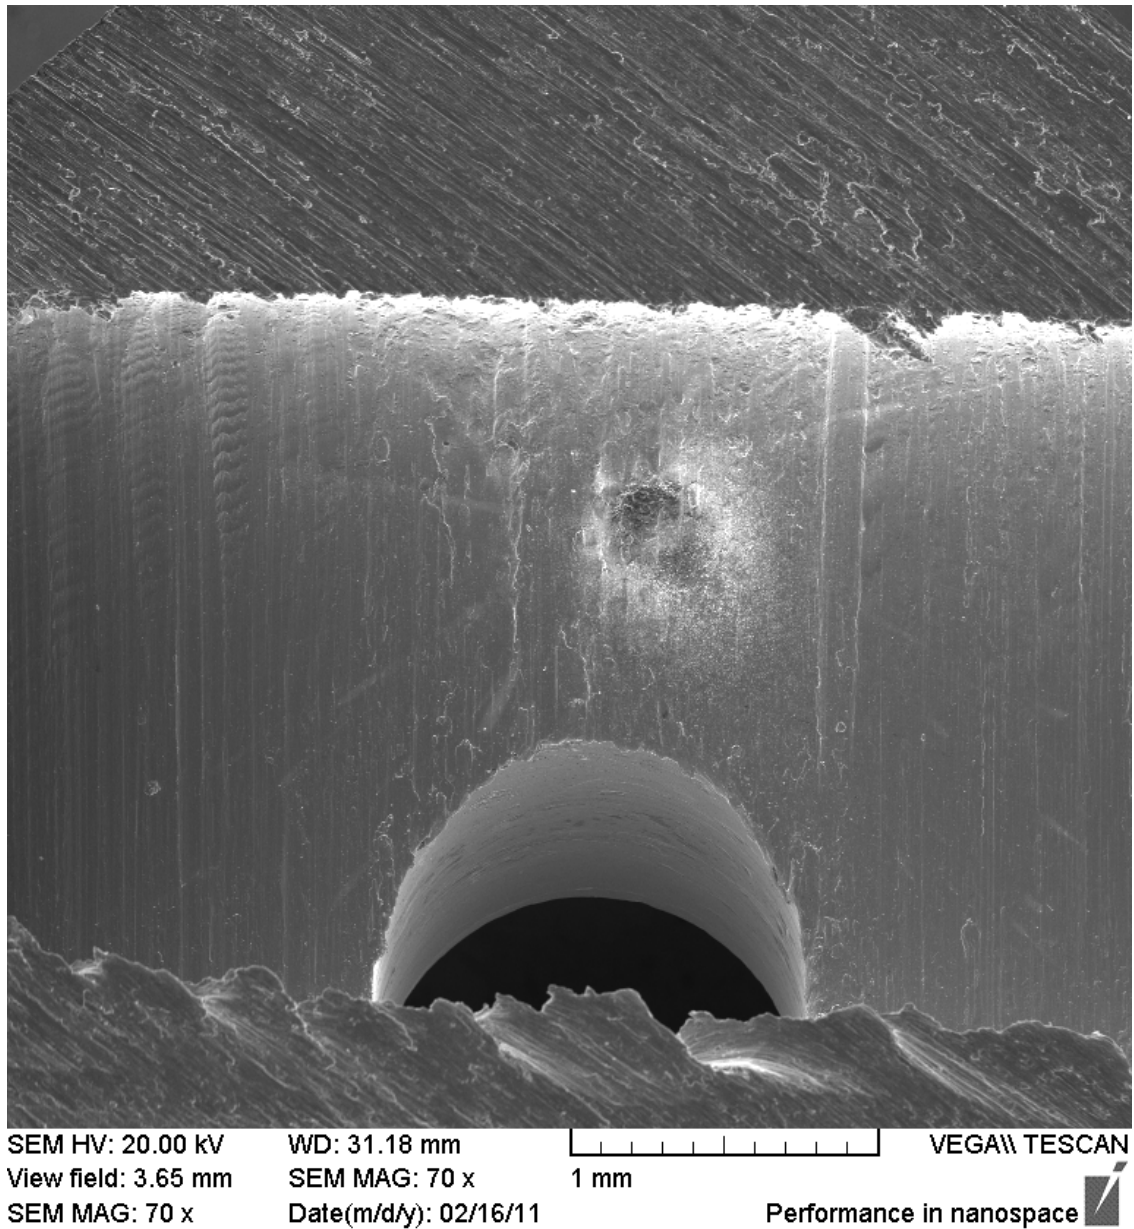
Figure 11. Surface appearance inside the transverse hole after a ten (10) second discharge duration. The obvious whitish pit shown just above the longitudinal half-tunnel is the damaged area. The long axis of the transverse hole is oriented approximately horizontally. Note the two surfaces at the top and bottom of the image, which were created by removing (cutting) the bottom end of the probe. Despite removing the bottom of the hole the evidence remained intact.

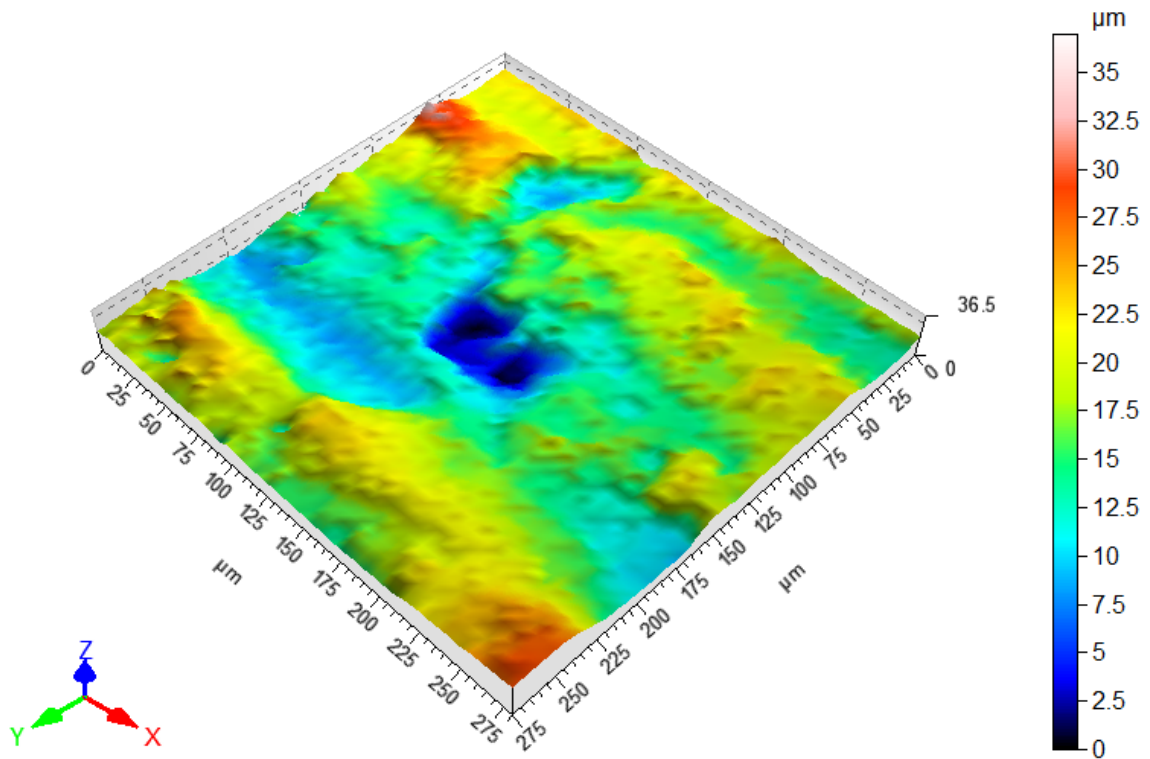
Figure 12. Surface profilometry measurement on the sample from Figure 11 – ten (10) second discharge duration. The pitted area is more than 20 micrometers deeper than the surface of the surrounding metal.

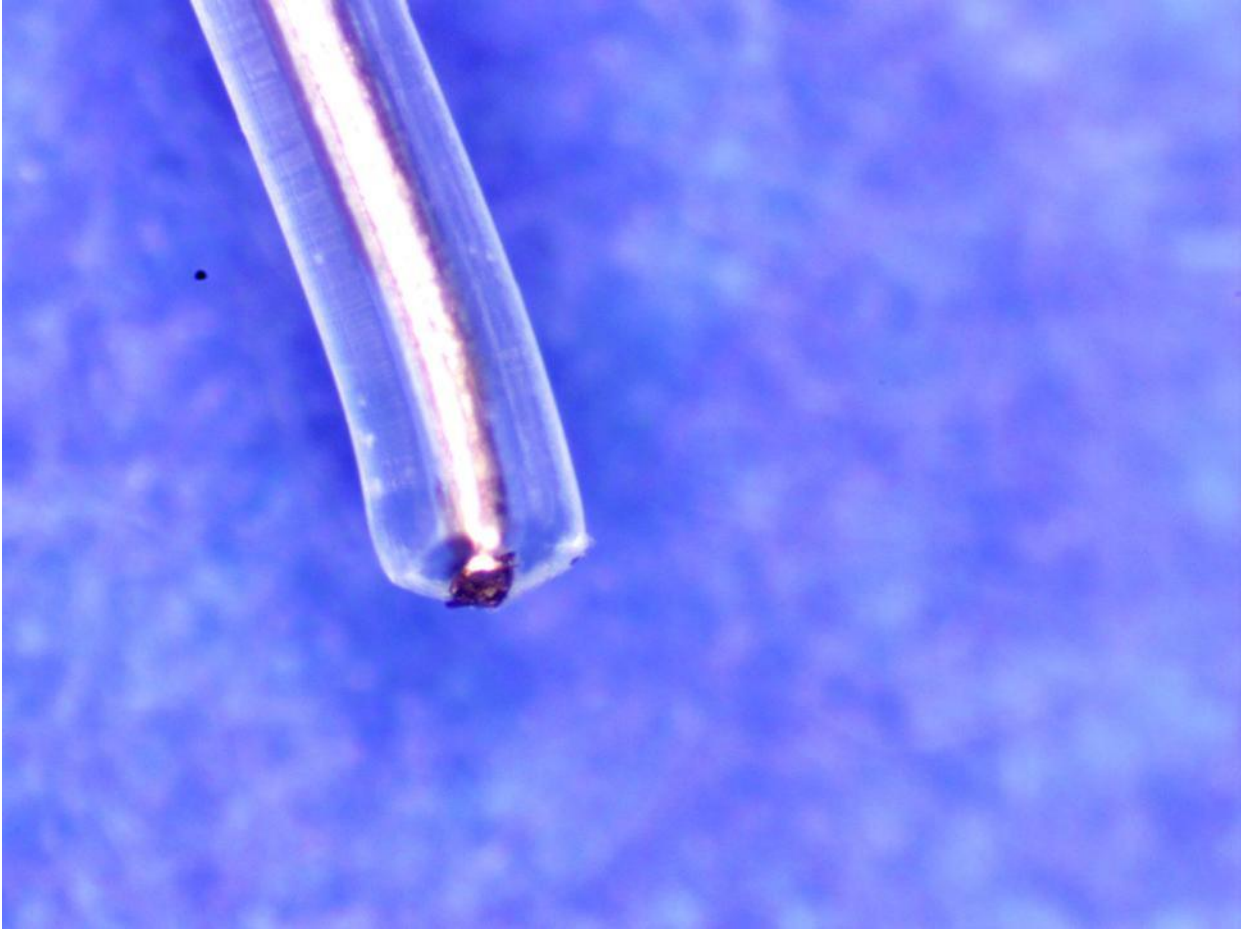
Figure 20. Wire end number 8. Note that the insulation and the wire are approximately in the same plane, indicating that the wire had been cut.

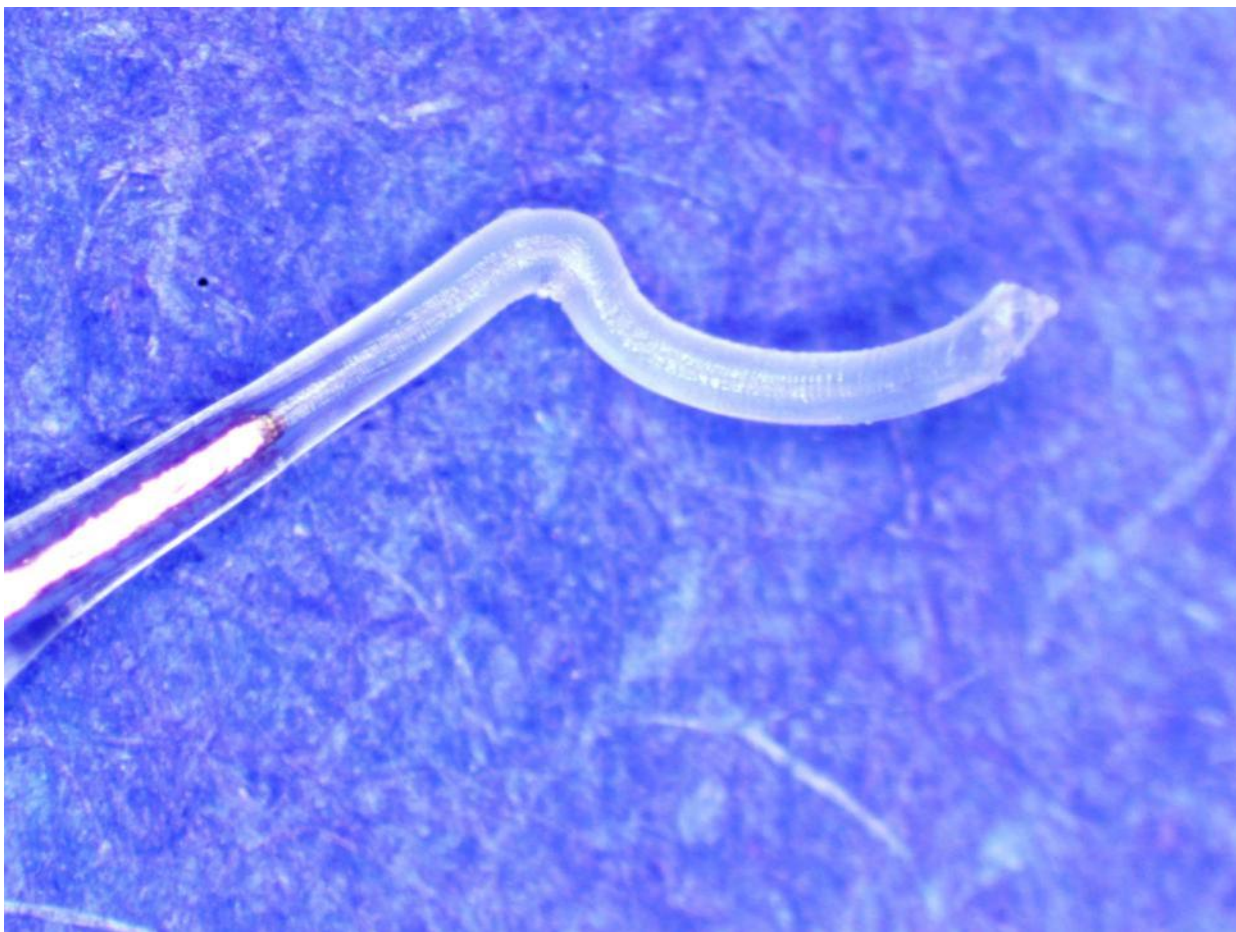
Figure 21. Wire broken end number 9. The insulation is extended past the wire tip thereby completely containing the wire and preventing direct wire contact.

6. Wire fractured under tensile conditions would remain contained within the stretched insulation, thereby preventing direct contact between the subject and the metal wire ends. This also creates an air gap that would have to be bridged through electrical arcing if the wire were to complete an electrical circuit. Thus, an electrical circuit with fractured wires could not have been established through the body of Mr. Piskura without creating visible evidence due to arcing between the wire tip and a contact point. Absence of such evidence on six (6) fractured wire ends examined, coupled with probe analysis, indicates that Mr. Piskura never received the attempted ECD discharge.

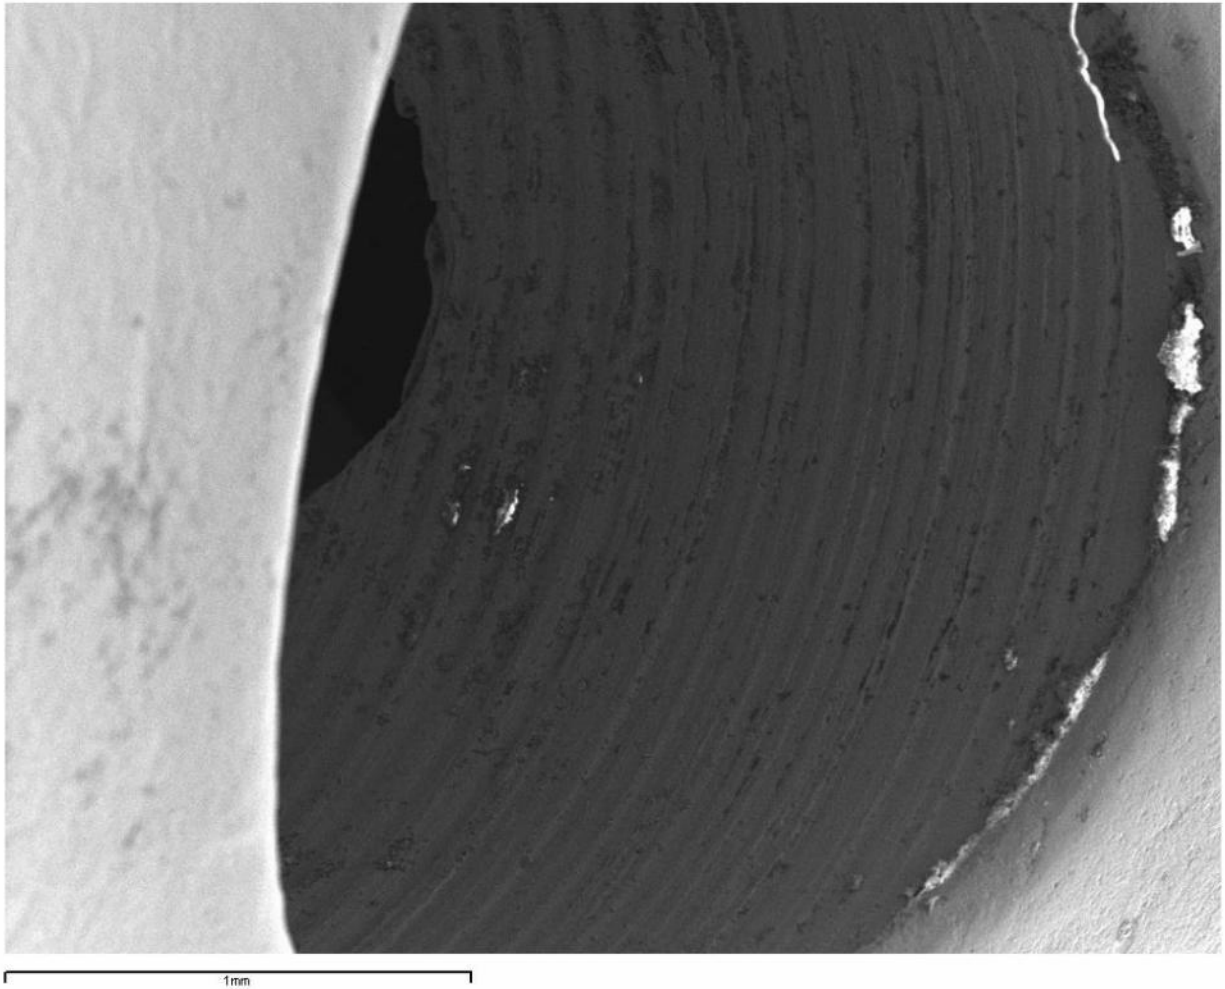
Both metal probes were inspected using optical microscopy as well as SEM. The probes did not contain tissue of any kind at the time of my inspection. Furthermore, no evidence, such as arcing witness marks inside the transverse hole of the probes where the wire rests, was found to indicate that electrical current had been flowing through both probes. Figure 22 and Figure 23 show the typical appearance of the transverse hole surface of probes A and B. Machine marks, resulting from drilling operation, are visible on both probes, indicating that the surface morphology has not changed since the probes were manufactured. Dark spots in the images are shadows created by the microscope and do not reflect changes in surface morphology. For comparison purposes, Figure 24 shows the appearance of the transverse hole surface of another probe with arcing damage. It is obvious that neither of the subject probes exhibited similar damage. In the absence of evidence indicating electrical arcing inside the transverse hole on

Figure 22. Typical surface appearance inside the transverse hole of Probe A at 12 o'clock. Only machining marks were observed. No disruption of material was observed consistent with arcing damage. The bright areas are nonconductive contamination.

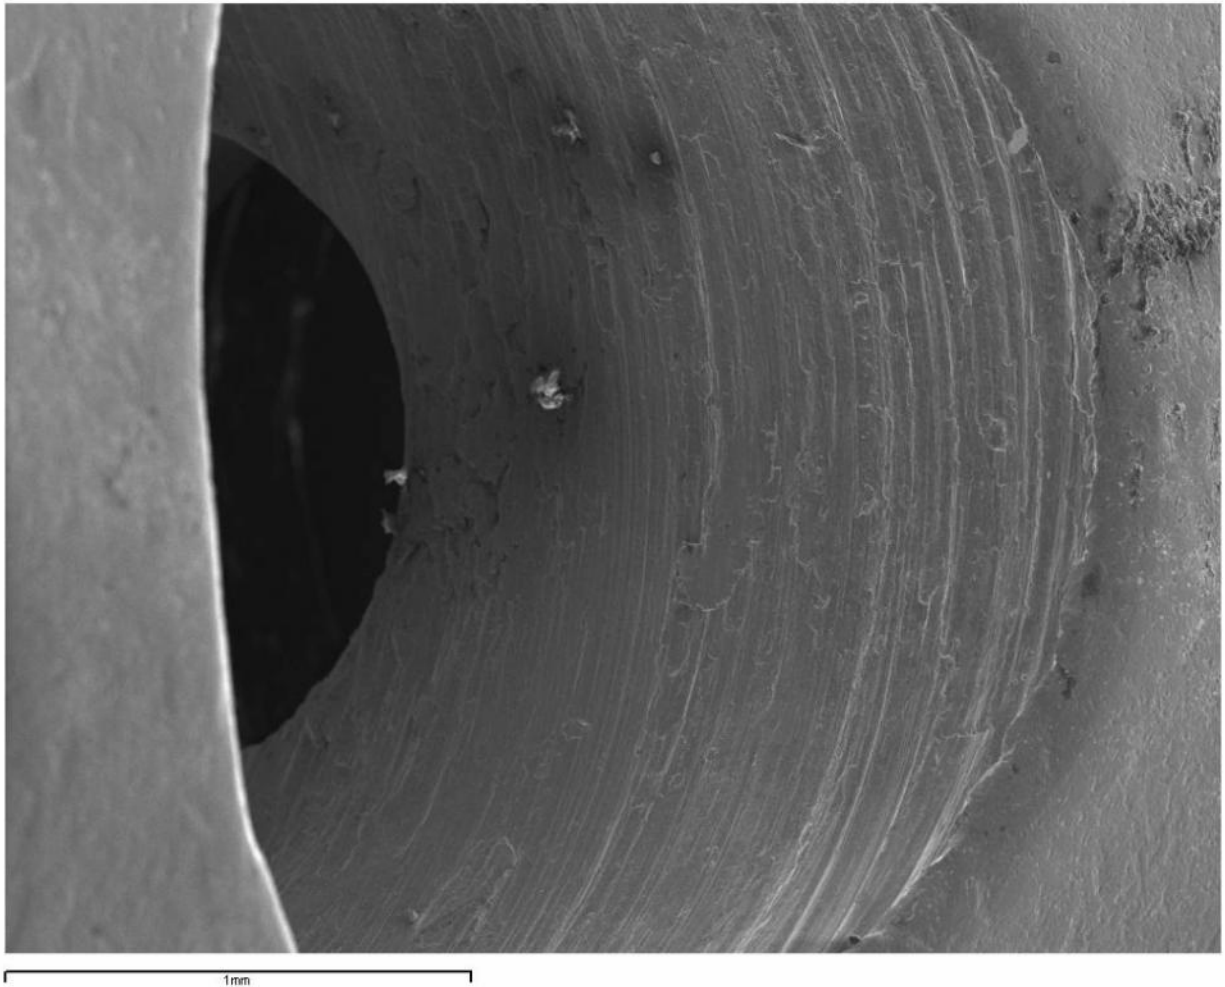
Figure 23. Typical surface appearance inside the transverse hole of Probe B at 12 o'clock. Only machining marks were observed. No disruption of material was observed consistent with arcing damage (i.e., no cratering, no deposition of material into peaks). The bright areas are nonconductive contamination.

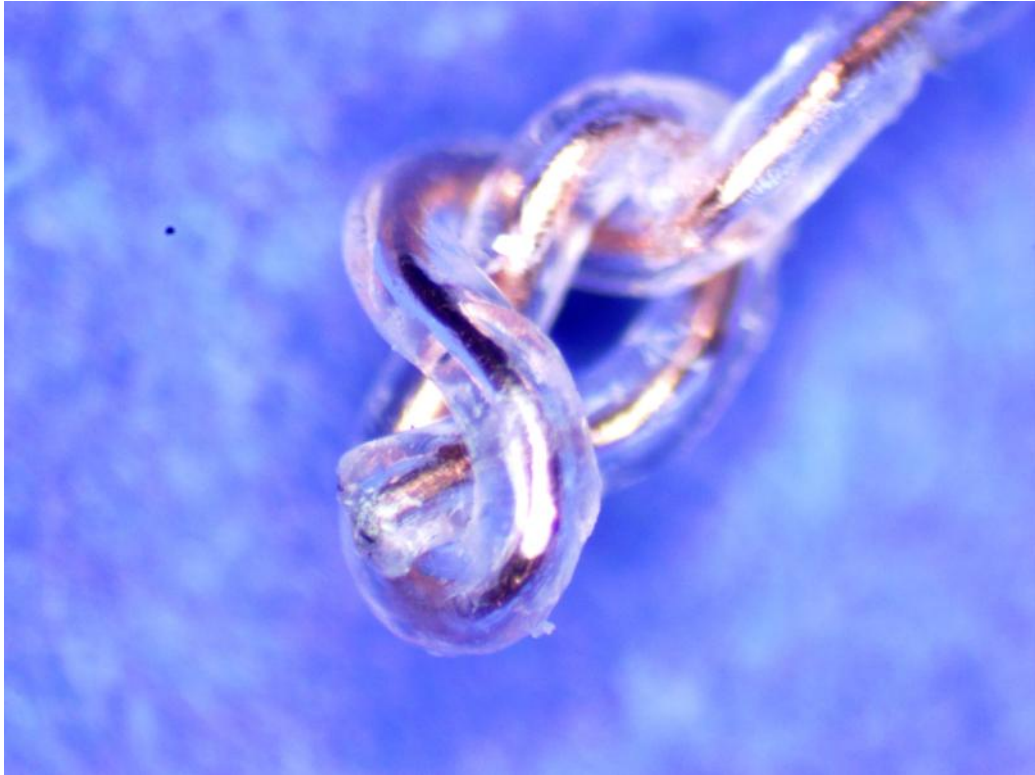
Figure 29. Appearance of wire end number 4 – knot end.

previously analyzed. In addition, the end of the wire at the knot from probe A appeared smeared consistent with contact with tweezers or similar extraction tool. At this time, it is unknown if any other end of the remaining separated wire portions was attached directly to probe B and if the knot that was contained in the transverse hole of probe B was untied at some point in time before I was able to review the evidence.
